## LEAD-BASED PAINT RISK ASSESSMENT REPORT

212 E Fillmore Avenue  
Orlando, FL 32809

January 23, 2023

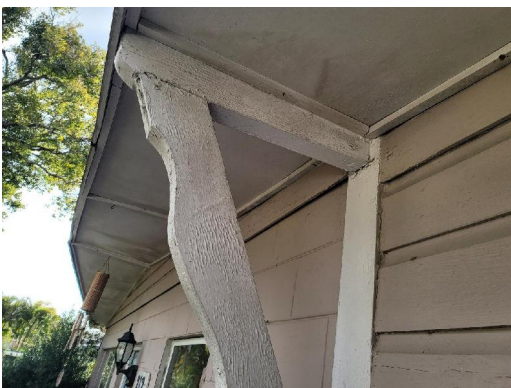
Read No.	Wall	Structure	Location	Member	Paint Cond	Substrate	Paint Color	Lead (mg/cm <sup>2</sup> )	Mode
001	Exterior								
009	A	Soffit	Ctr	Support	I	Wood	White	3.0	QM

Exterior(001) A-Wall, Center  
Wood Soffit Support  
Lead-Positive, Intact

- Option A. Paint film stabilization by application of 1 coat of Kilz primer or equivalent over a LSWP prepared surface and 2 top coats of exterior exposure residential paint following manufacturer's recommendations. Color chosen by owner. (IC)
- Option B. Enclosure of all lead-positive components with metal coil stock using LSWP.
- Option C. Encapsulation of lead-positive components by application of LBC (Lead Barrier Compound) using LSWP.
- Option D. Removal of lead-positive components and replacement with material similar in appearance, composition, and finish using LSWP.
- Option E. Remove lead-based paint chemically and repaint using LSWP.
